ISMP ALERTS (/TAXONOMY/TERM/36)

# Prefilled Opioid Syringe Attracted by MRI Magnet

February 22, 2018

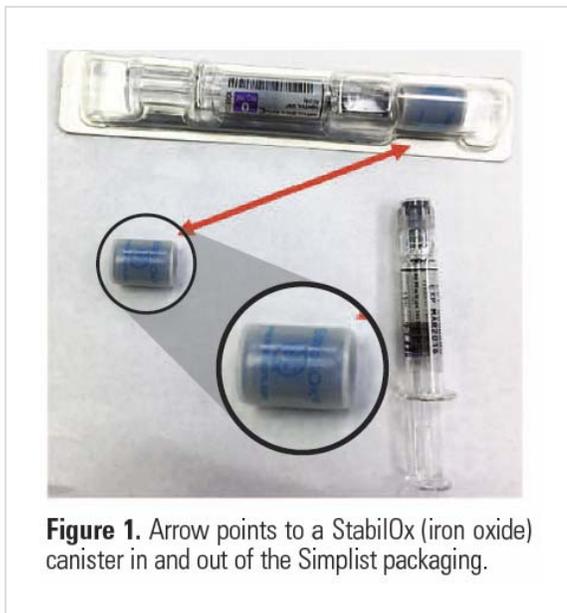
We learned of an incident last week involving an unopened DILAUDID (**HYDRO**morphine) prefilled syringe (SIMPLIST, Fresenius Kabi), which was brought into a room housing a magnetic resonance imaging (MRI) scanner. An MRI scanner has an extremely strong magnetic pull. The Simplist package contains a STABILOX canister that holds iron oxide, which serves to prevent oxidation of the drug (**Figure 1**). MRI staff need to be aware that the iron oxide in

the canister is ferromagnetic. Ferromagnetic objects brought into the MRI scanner room can become a projectile. In this case, the magnetic pull from the scanner drew the Simplist package to the magnet with considerable force. No one was harmed in the incident, but the enclosed glass Dilaudid syringe apparently shattered. Both Dilaudid and morphine syringes in Simplist packaging have this StabilOx canister.

MRI technicians should be informed of the above issue with Simplist syringes that contain StabilOx canisters so these items do not enter Zone 3 or 4. For inpatients, medication doses should be administered prior to transport to the MRI suite.
